Brief Description:

Monitoring Report:

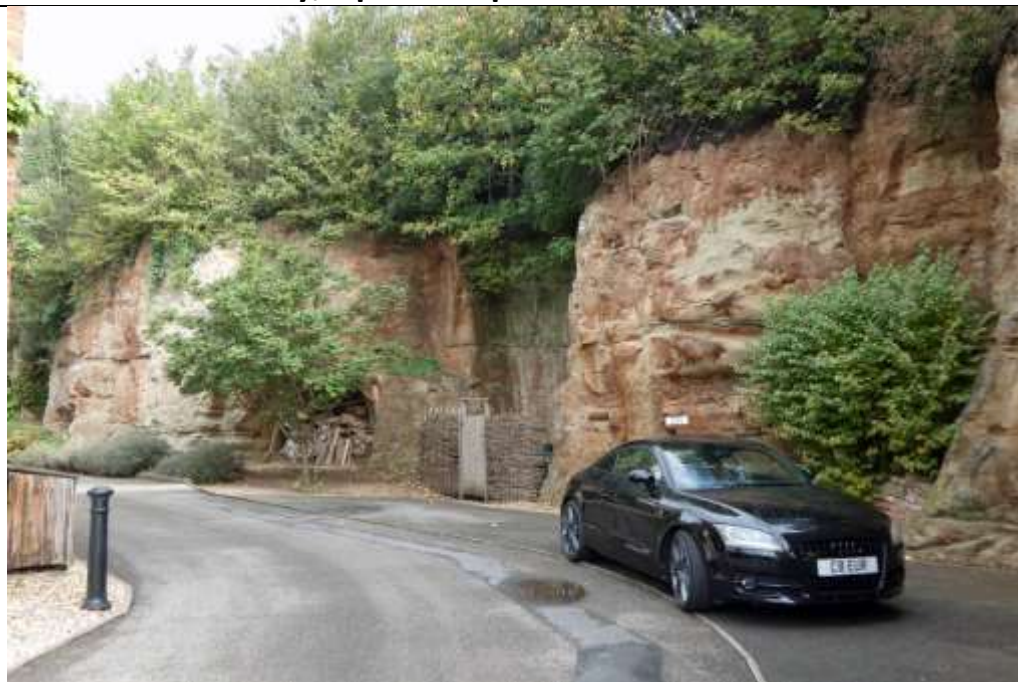
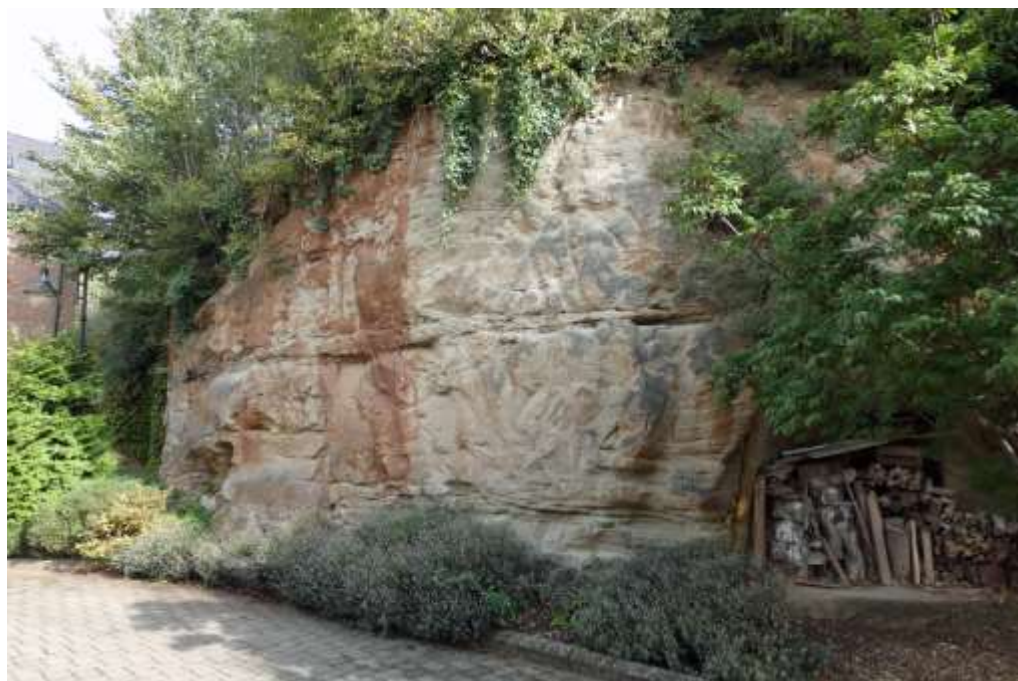
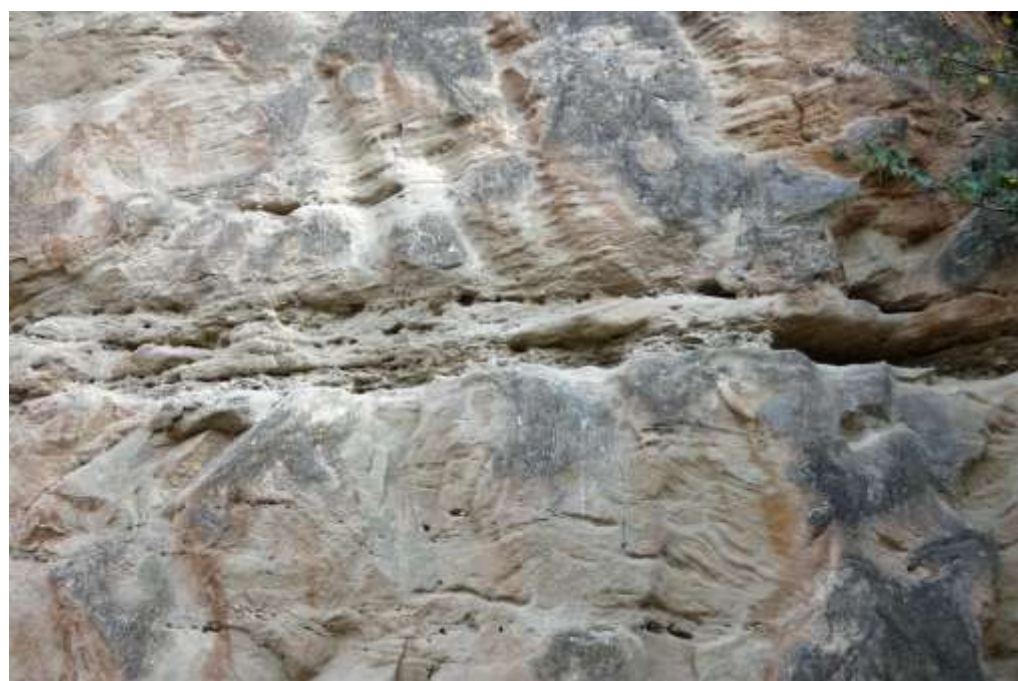
- The Rock Mill Quarry site is easily accessed by approaching along Rock Mill Lane from the Rugby Road. However, note that the surroundings of the quarry are now the private property of the residents of the Rock Mill complex.
- Cars must be parked on the public roadside along Rock Mill Lane before reaching Sir Anthony Eden Way.
- To visit the site, permission should be sought from the Managing Agent of the Rock Mill Management Company.
- The sketch map of the area included in our documents for the site is completely out of date and needs to be re-drawn.
- The area shown as the site is almost certainly wrong in the first instance and is a level area, adjacent to the river, containing new private residential buildings.

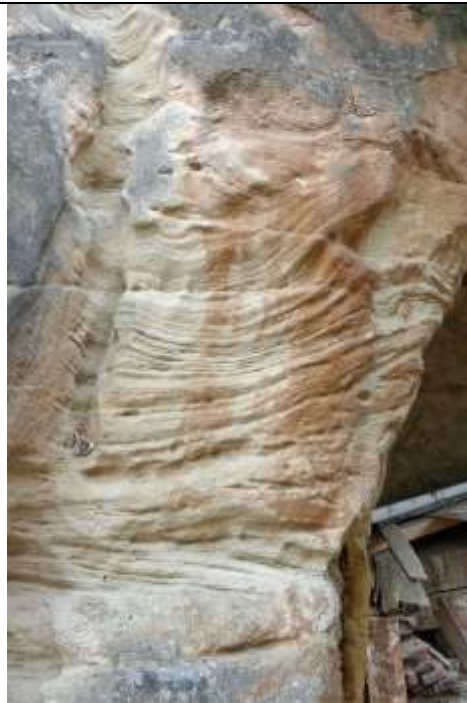
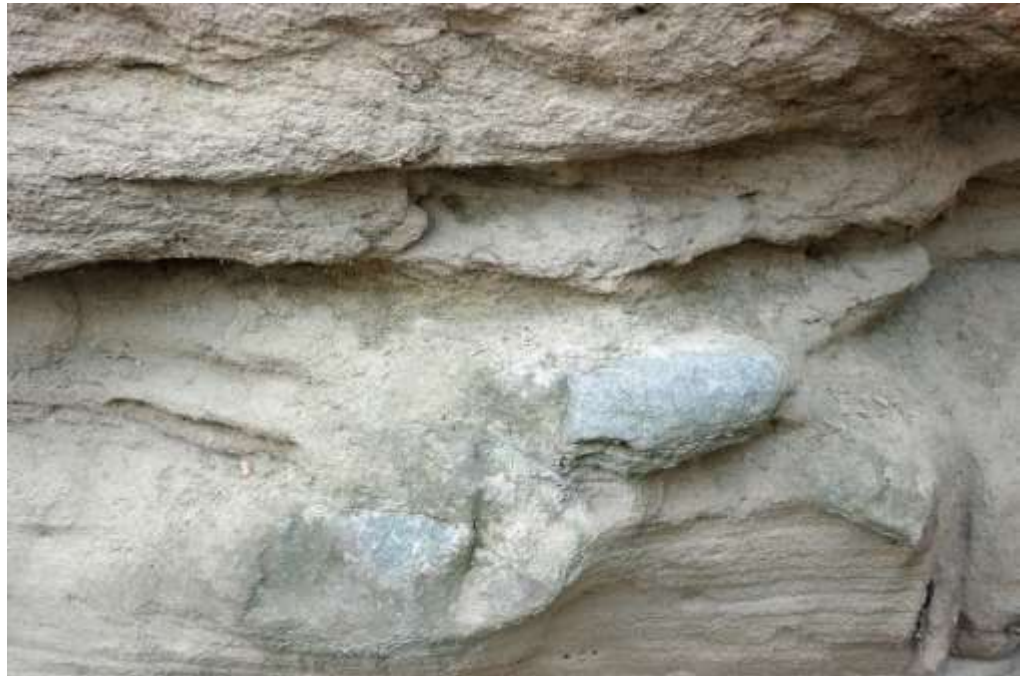
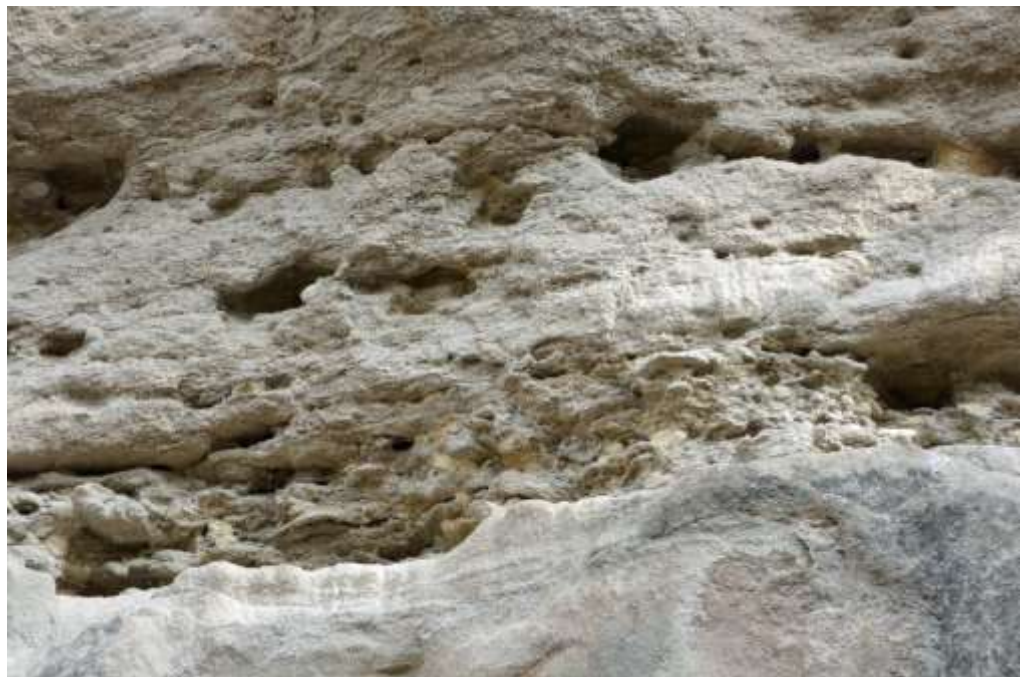
- The quarry wall that runs north south adjacent to the buildings is accessible as an exposure in the southern half and is represented in the photograph in our existing records.
- North of this position, the section is heavily overgrown and appears to be in a more private location.
- The exposed quarry wall appears to be in a very good condition, readily displaying all of the geological features described in our text of the site.
- There has been some growth of the shrubs and trees around the site, as can be seen from the new photograph. At present the further growth does not appear to be a problem but in due course some consideration should be given to their reduction, if possible.
