LGS 38 Winderton Road Cutting Update 10 Jan 2017

Grid Ref: SP 3414540850

Monitoring Report

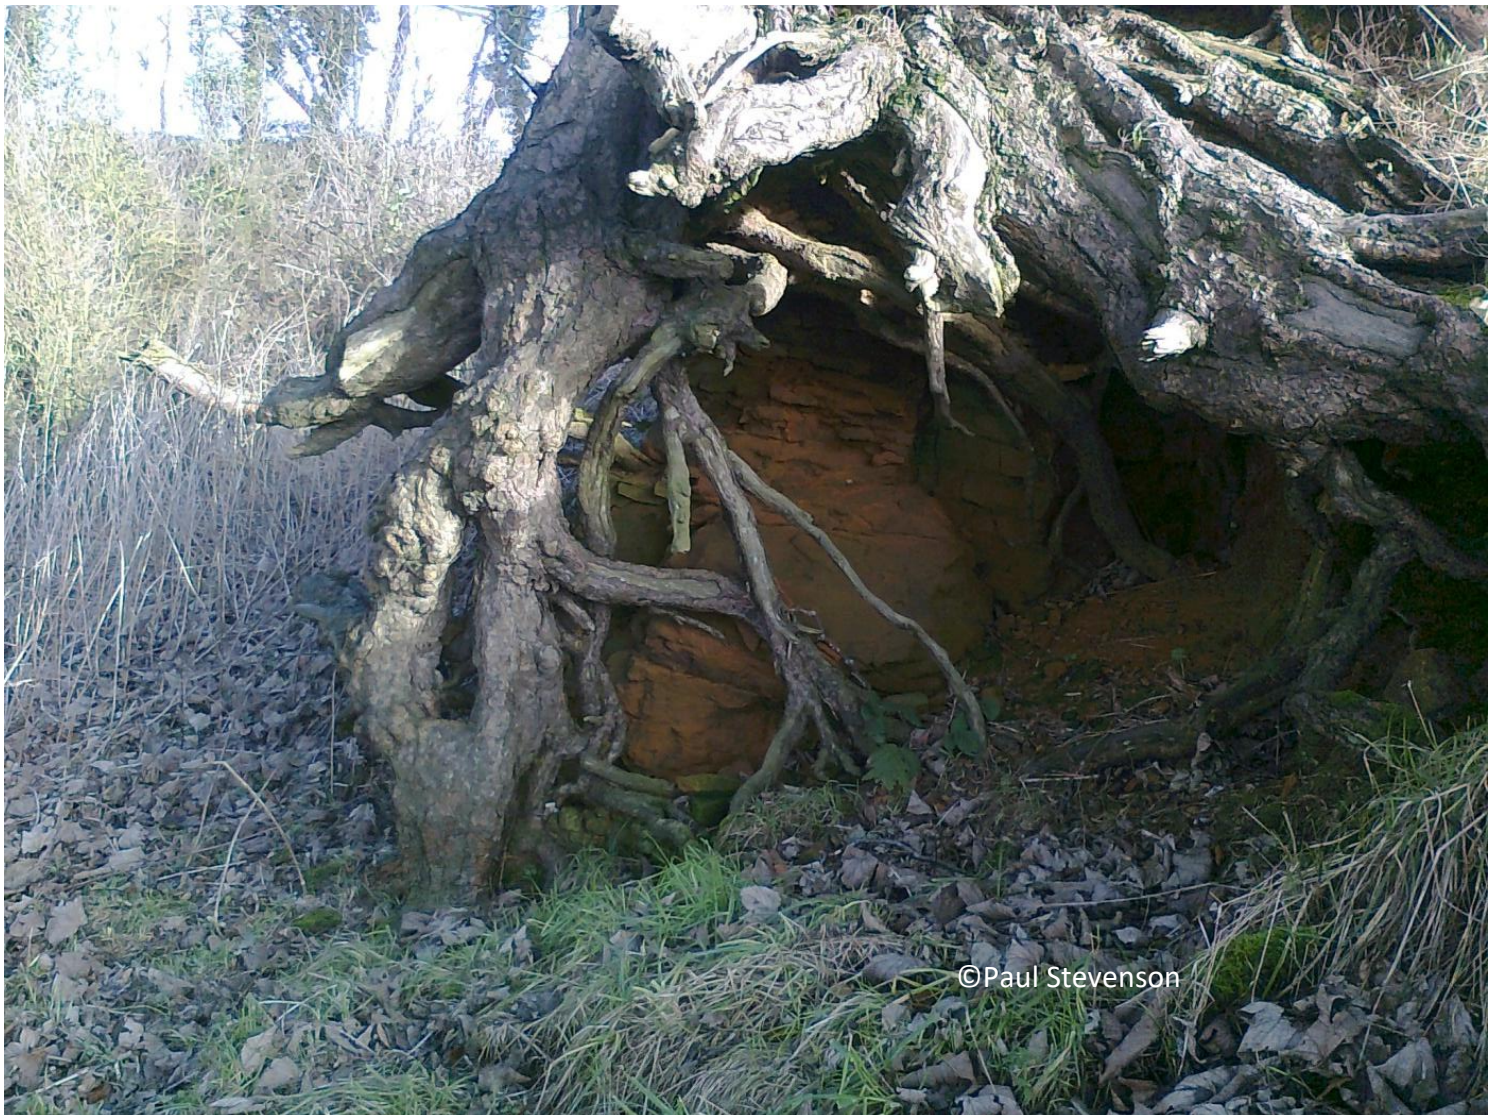
The photograph below is not the full extent of the exposure; the other part is just behind (to the East) of this piece. This piece shown in the photo is being protected (?) by a medium sized probably Scots Pine. When this falls over in the next 5-10 years it will cause damage but hopefully expose a new face. Pieces of iron ore can be found on the ground. The site could benefit from some strimming and digging out of the talus build up.
