LGS 42 Moor Wood Quarry Update 17 Sep 2017

- A small exposure in a disused quarry of a Caledonian 'Diorite' sill intruded into the Outwoods Shale Formation of the Stockingford Shale Group. The exposure shows the contact between the diorite and the shale.

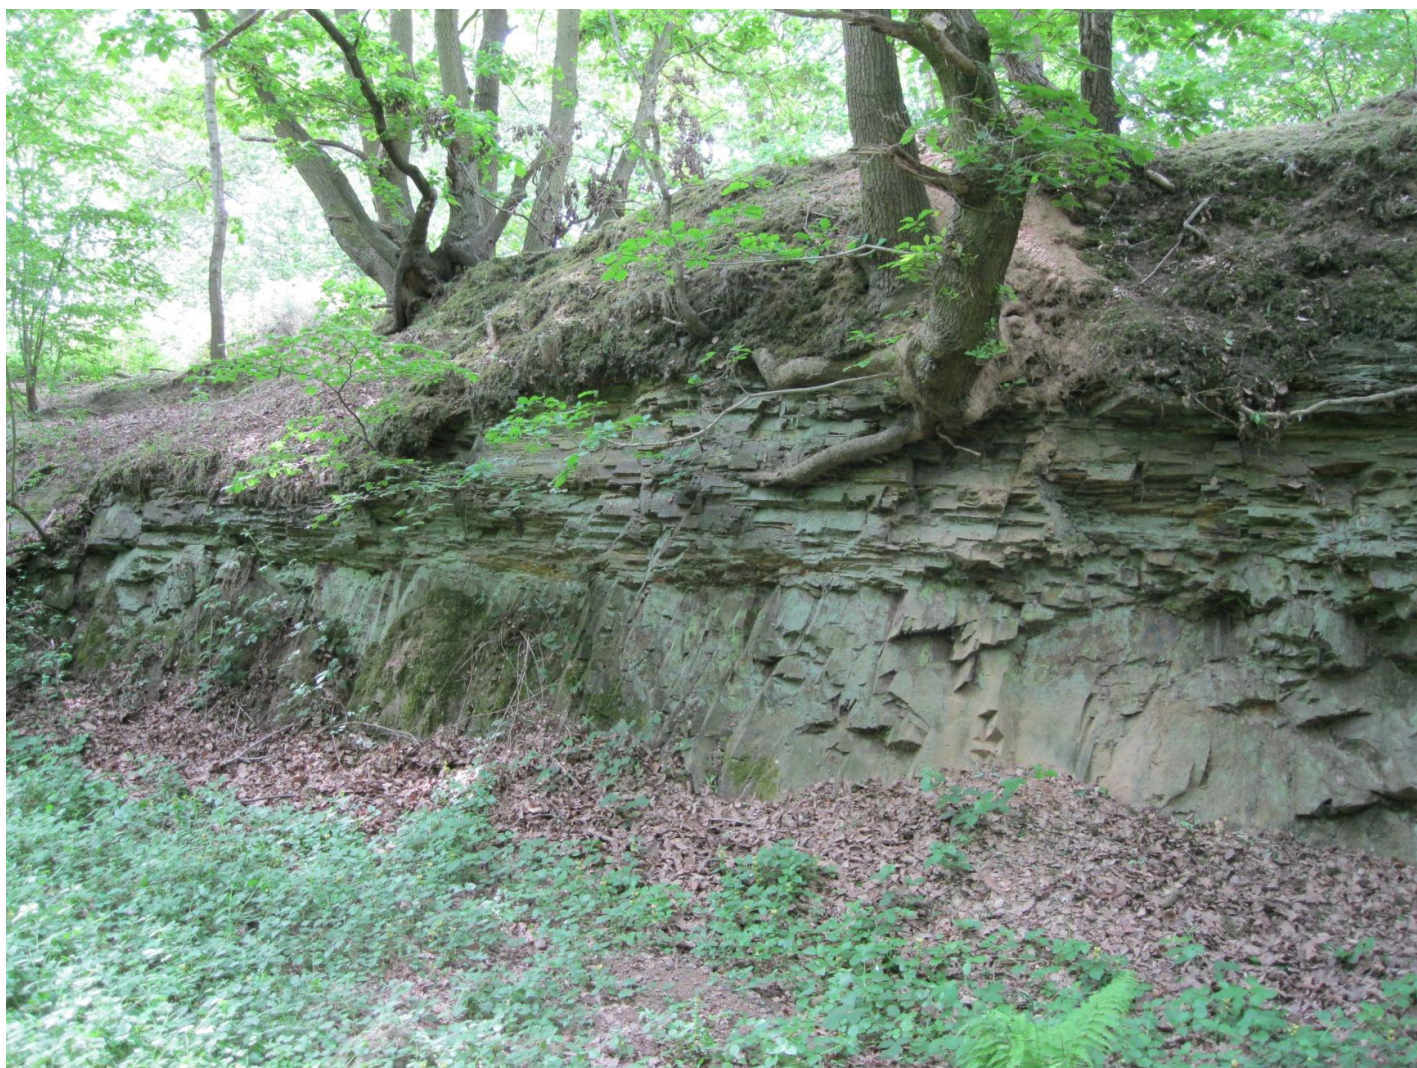
- Note any safety issues **See above**
- Assess the condition noting whether any of the following factors adversely affect the feature:
 - Vegetation Growth **see above**
 - Dumping or landfill **see above**
- If the feature is bedrock or a superficial deposit, note if it is still exposed. **The outcrop, which is the feature of interest, is still in excellent condition and once you have gained access is still clear of vegetation.**

2011 photograph of Moorwood Quarry Face OS NGR SP3184093740 look SW
