Warwickshire Geological Conservation Group (WGCG)

Local Geological Site - LGS 65 Canley Brook, Update September – October 2020

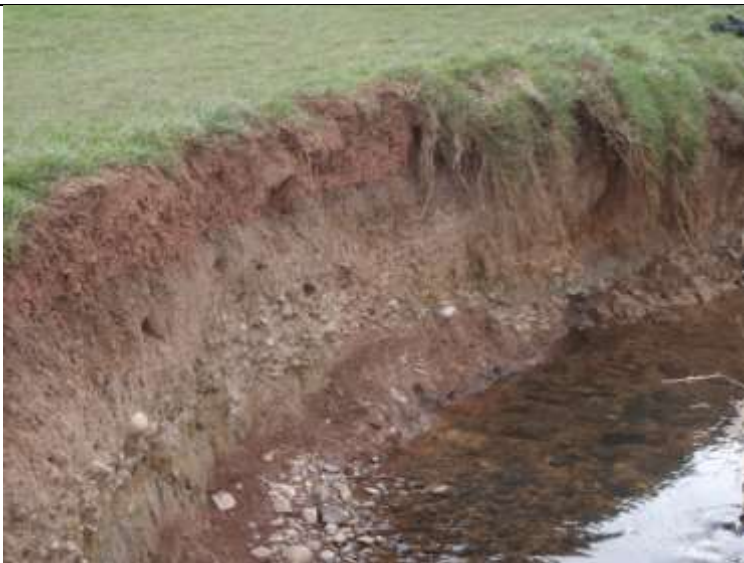
Above: Canley Brook Flood Plain Deposits (2013)

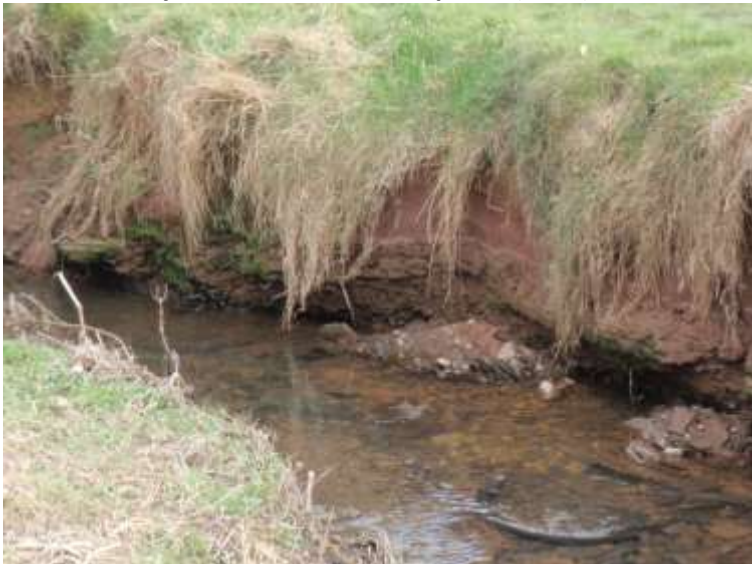
Above: Canley Brook Weathered Mudstone in the Stream Bank (2013)

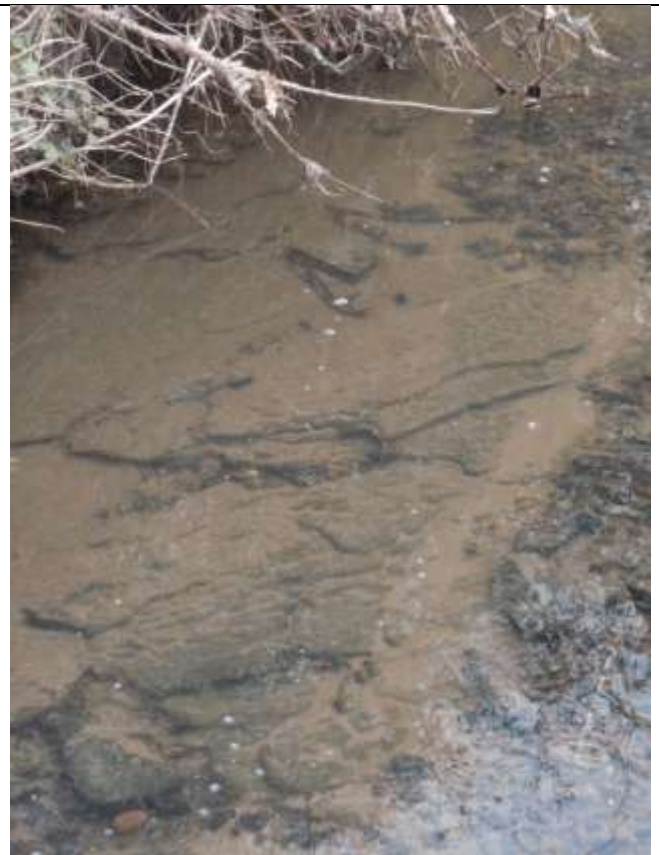
Above: Canley Brook Sandstone Outcrop in the Stream Bed (2013)

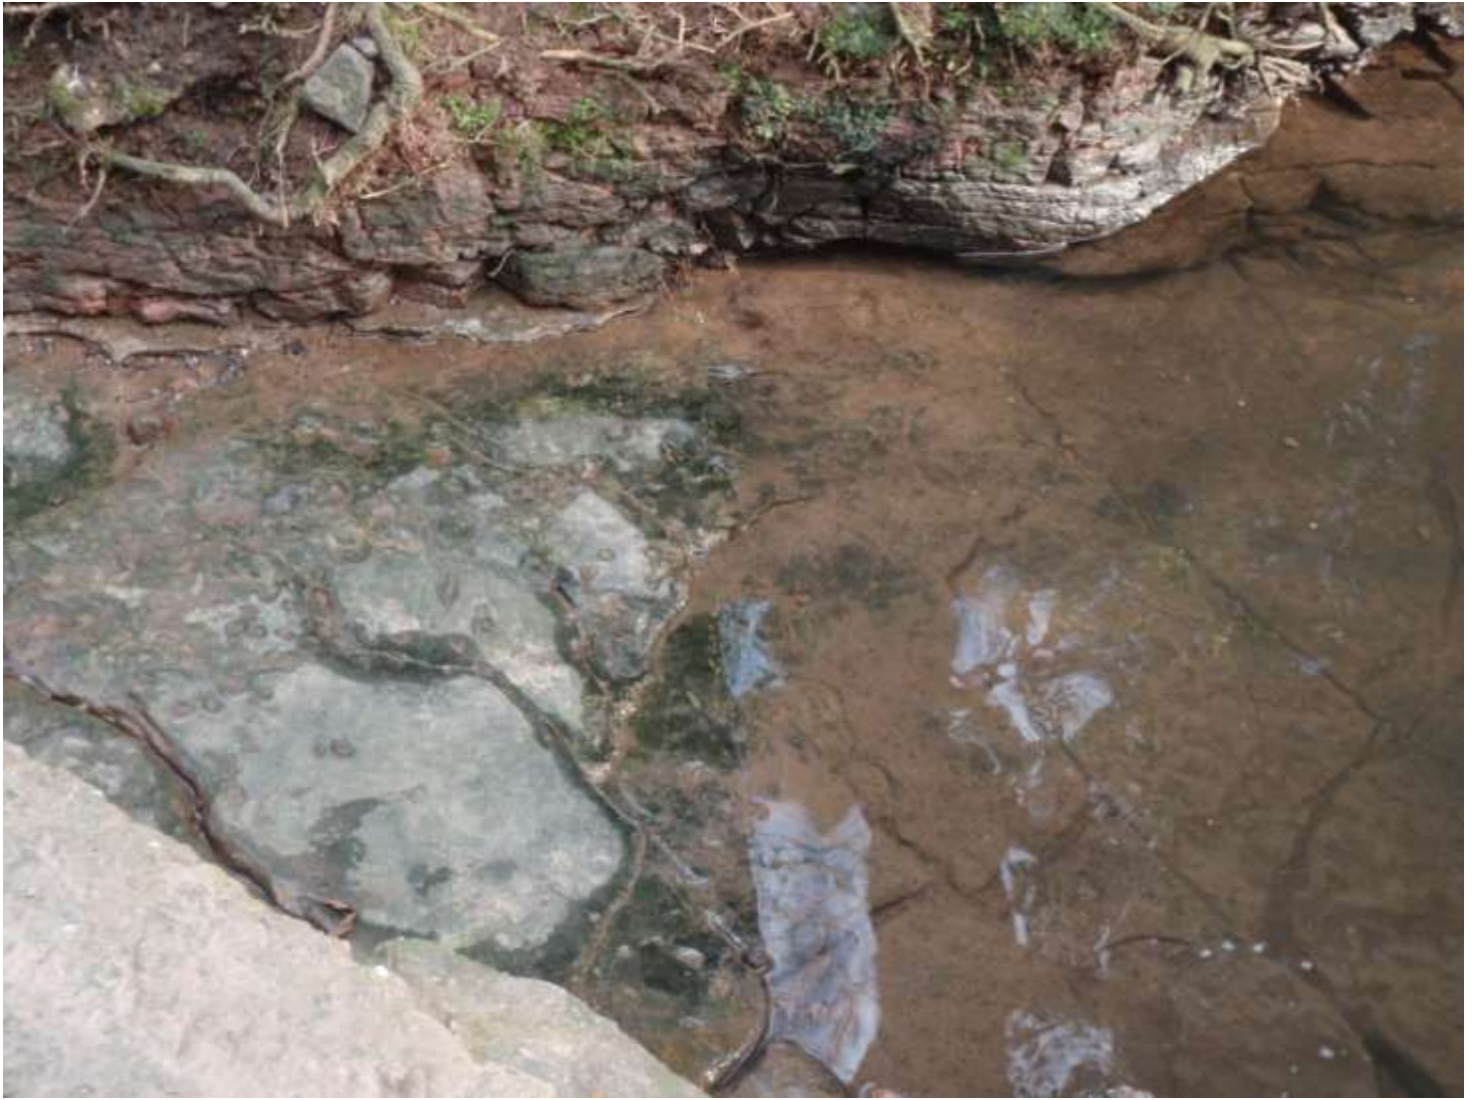
Downstream from Section 4 and beyond the LGS there are much better exposures of sandstones at Canley Ford (SP313770). This is accessible on the foot path from the Esso Filling Station on the A45, or on the Canley Ford track from the Memorial Park.

Above: THMF Sandstone at Canley Ford
