Brief Description:

MONITORING REPORT

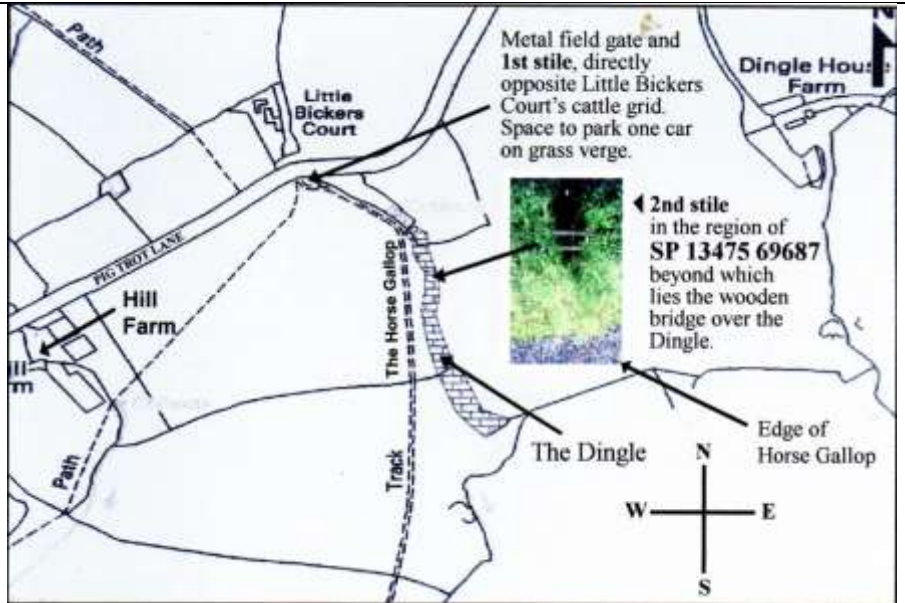
Above, Fig 1 at SP 13475 69687

Map showing our route from the metal field gate via the Horse Gallop to the bridge over the Dingle.

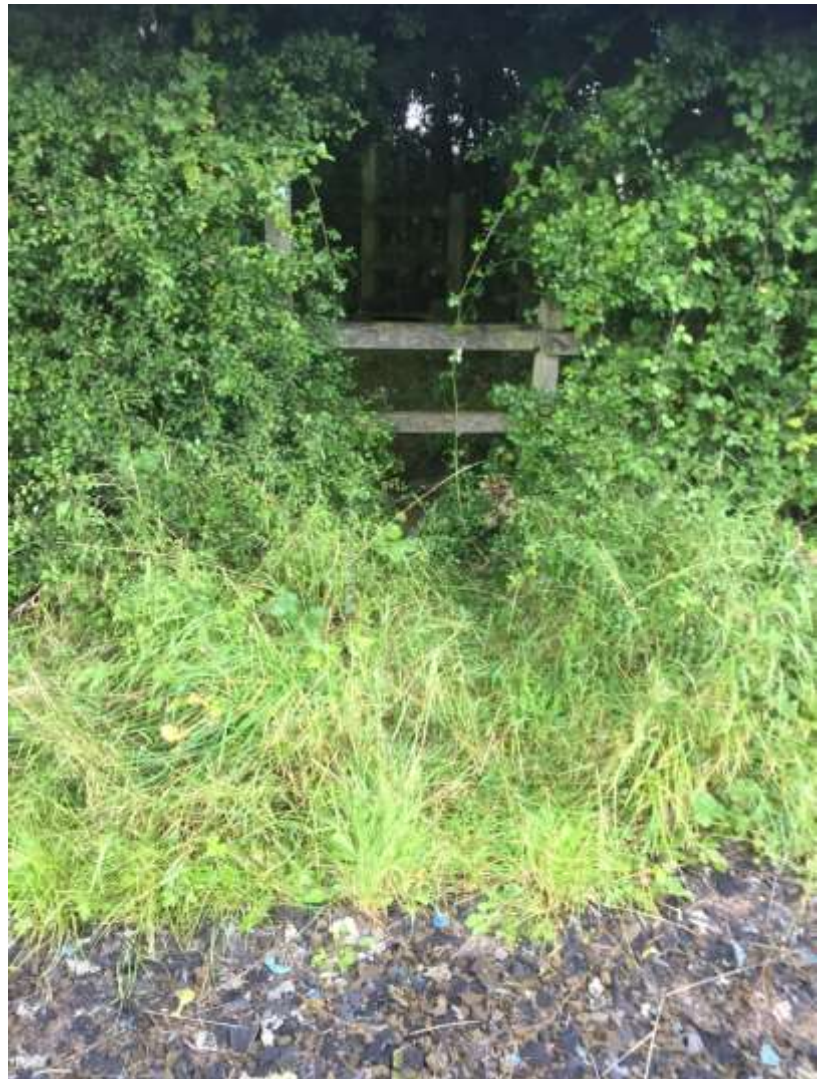
Above: Fig 2 at SP 13475 69687.

The partially concealed stile which led to the bridge over the Dingle. Fortunately, the stream was barely running at this point and the tall banks were dry enough to make it safe for Mike to descend into the watercourse and make his way through overhanging brambles and branches towards the waterfalls.

- The metal five bar gate off Pigs Trot Lane and the stile at its side were both in good condition as was the stile and wooden bridge over the Dingle.

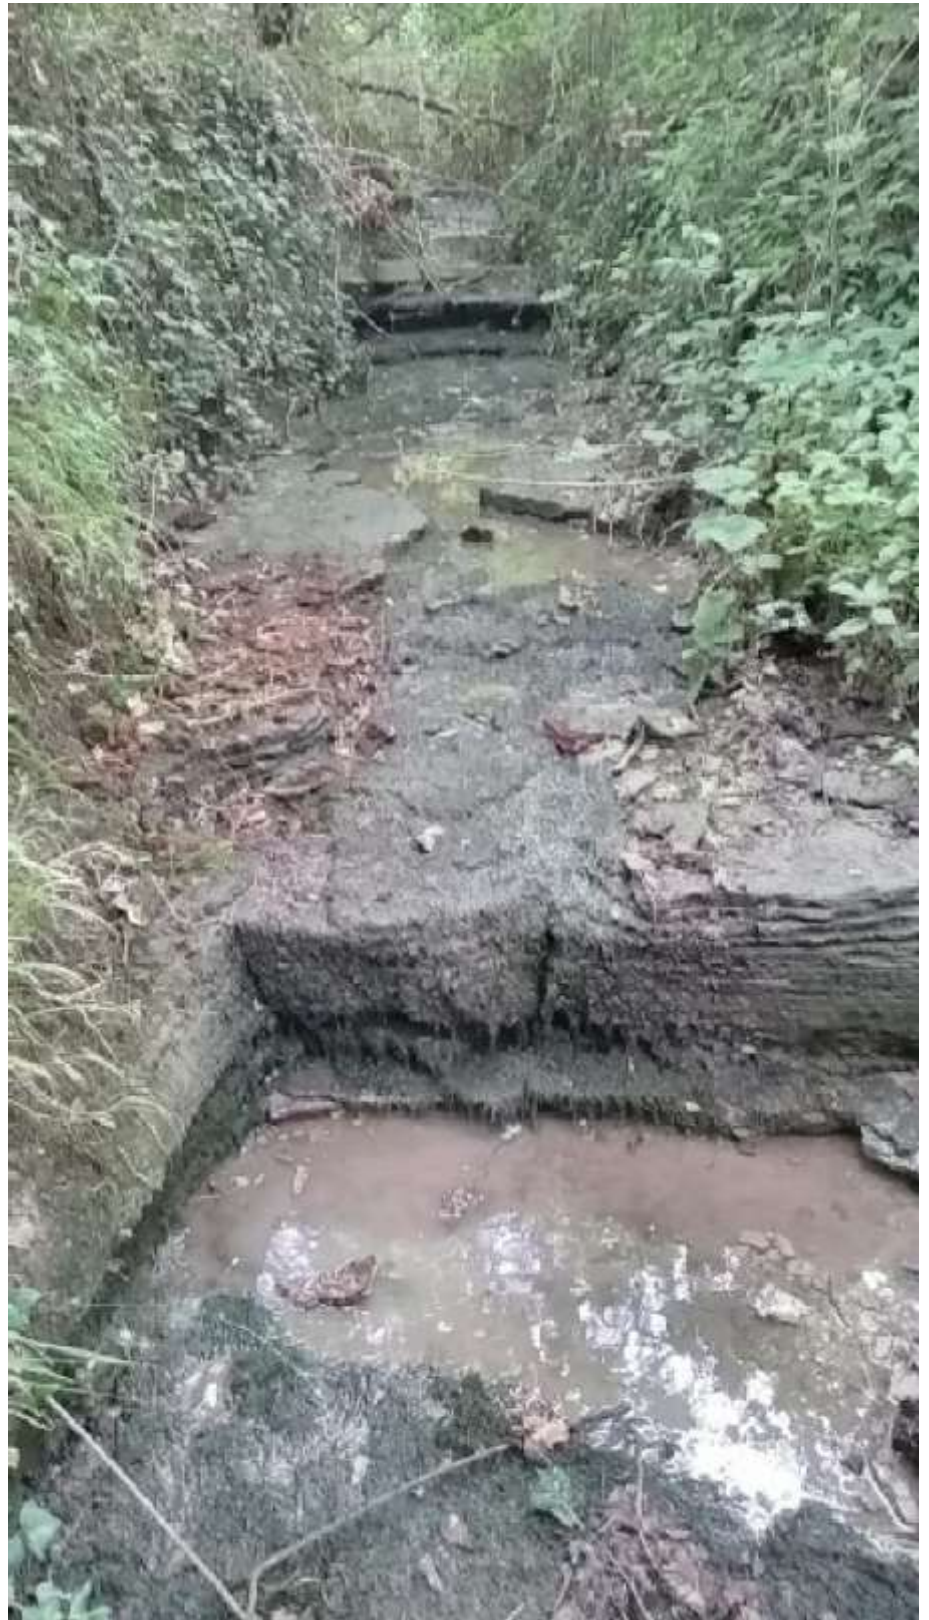
Above. Fig 3 at SP 1354 6947.

The stream bed close to the bridge, descending in steps 6 to 9 inches in height over eroded bedding planes.

The photograph was taken when the stream was barely flowing. At other times this approach would have been impossible.

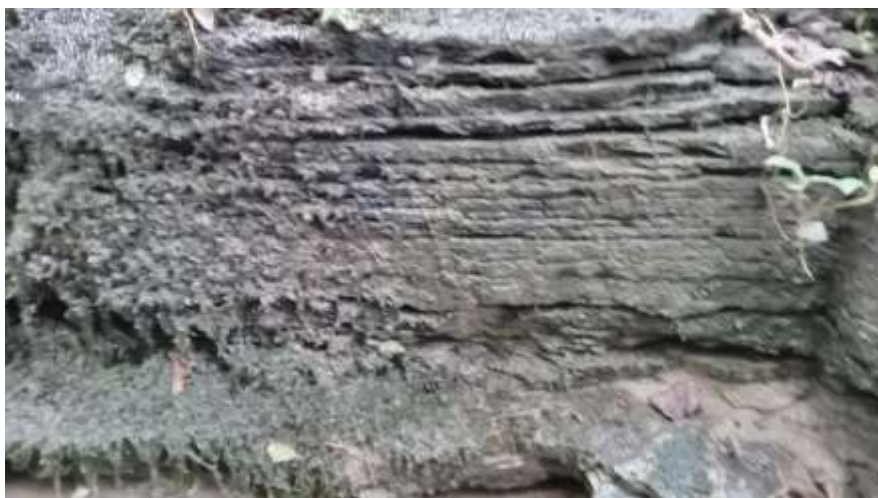
Above. Fig 4 in the region of **SP 135 697**.

Close up showing bedding planes close to the waterfall.
