Warwickshire Geological Conservation Group (WGCG)
Local Geological Sites - LGS 01 Roundberry Quarry, Update May 2019

Monitoring Report:

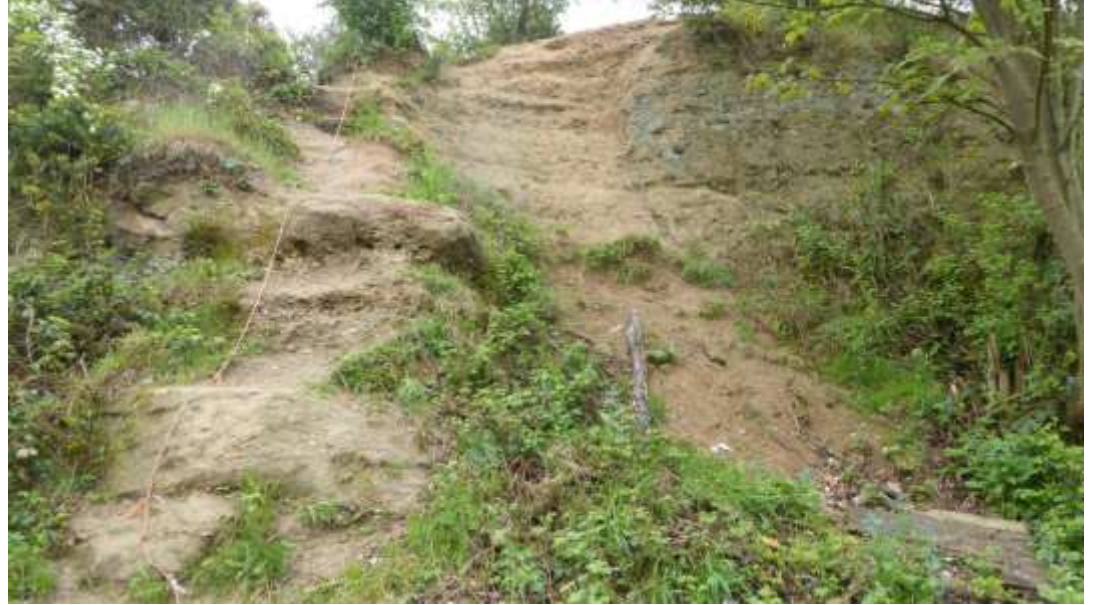
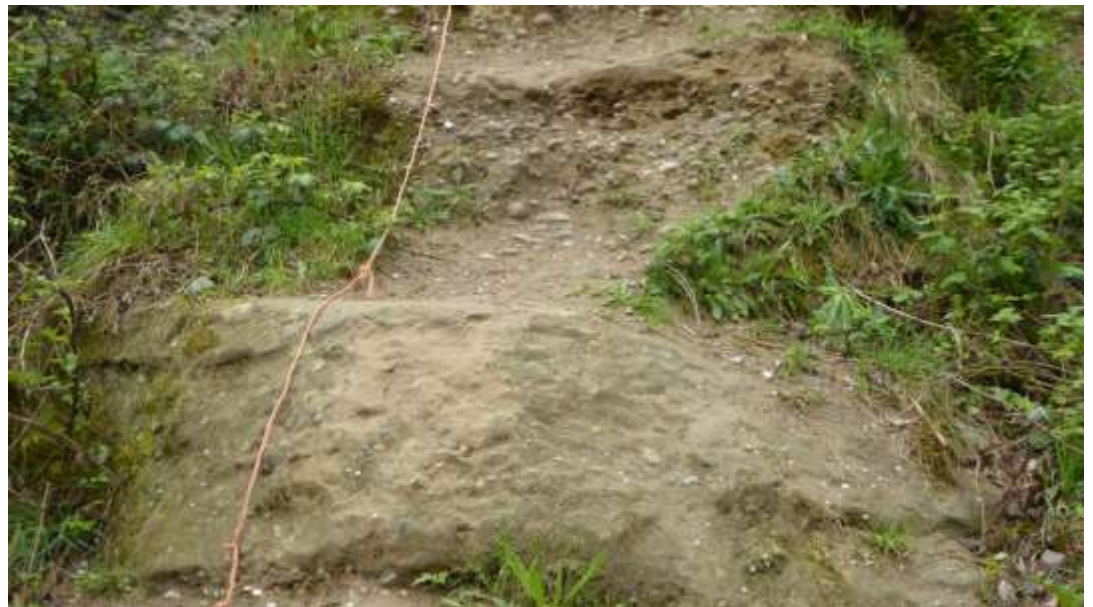
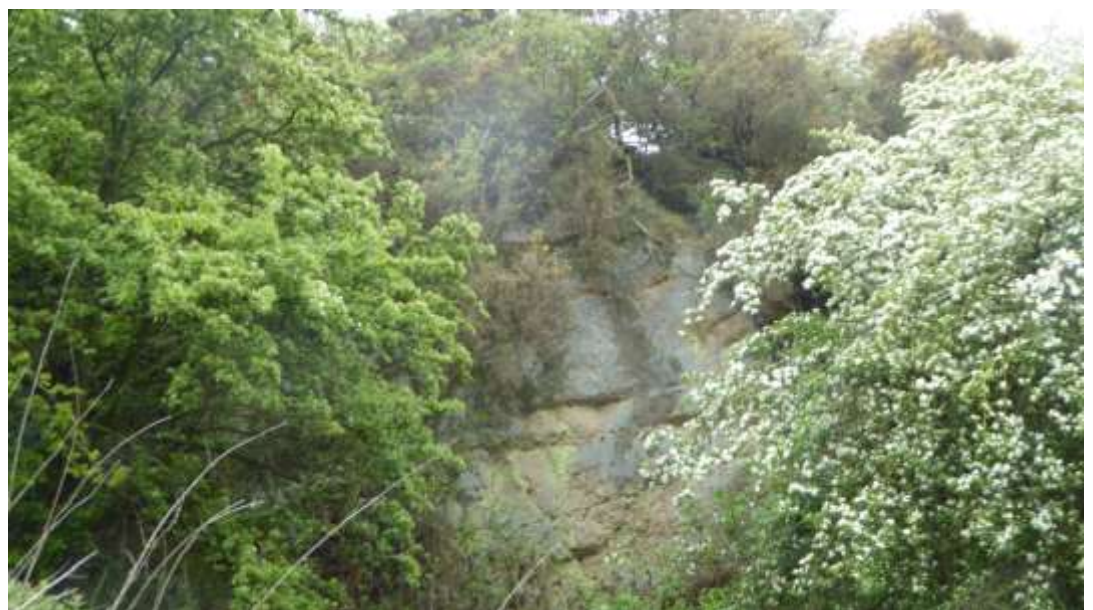
East Face

- The quarry floor is very overgrown with brambles and nettles.
- There was evidence of barbecues and some litter.
- The condition of the East wall indicates it being used by locals for climbing, a rope was fixed down one of the best exposures (pictures 1, 2 and 4). This activity probably helps to keep vegetation at bay.

- While the East and South faces were still partly visible and still showed the described features, the exposure was much less than the 80% reported in 2009, I estimate much less than

50% and this will decrease further with the annual growth of brambles in particular.

- The West face was not visible, being completely overgrown and impossible to get close to.
- Clearance of much of the vegetation on the East and South faces should be reasonably easy if permission is obtained.
- The West face would be more difficult. As this site is described in the information sheet as “the only good exposure of the Triassic Polesworth Formation formerly known as the Bunter Pebble Beds and of considerable educational value at all levels” clearance of some of the vegetation would be advantageous.
