**Warwickshire Geological Conservation Group (WGCG)
Local Geological Site - LGS 38 Winderton Road Cutting Update 10 Jan 2017**

A road cutting on the south side of the road that runs close to the south side of Compton Wynyates House revealing a section in the Northampton Sand Formation

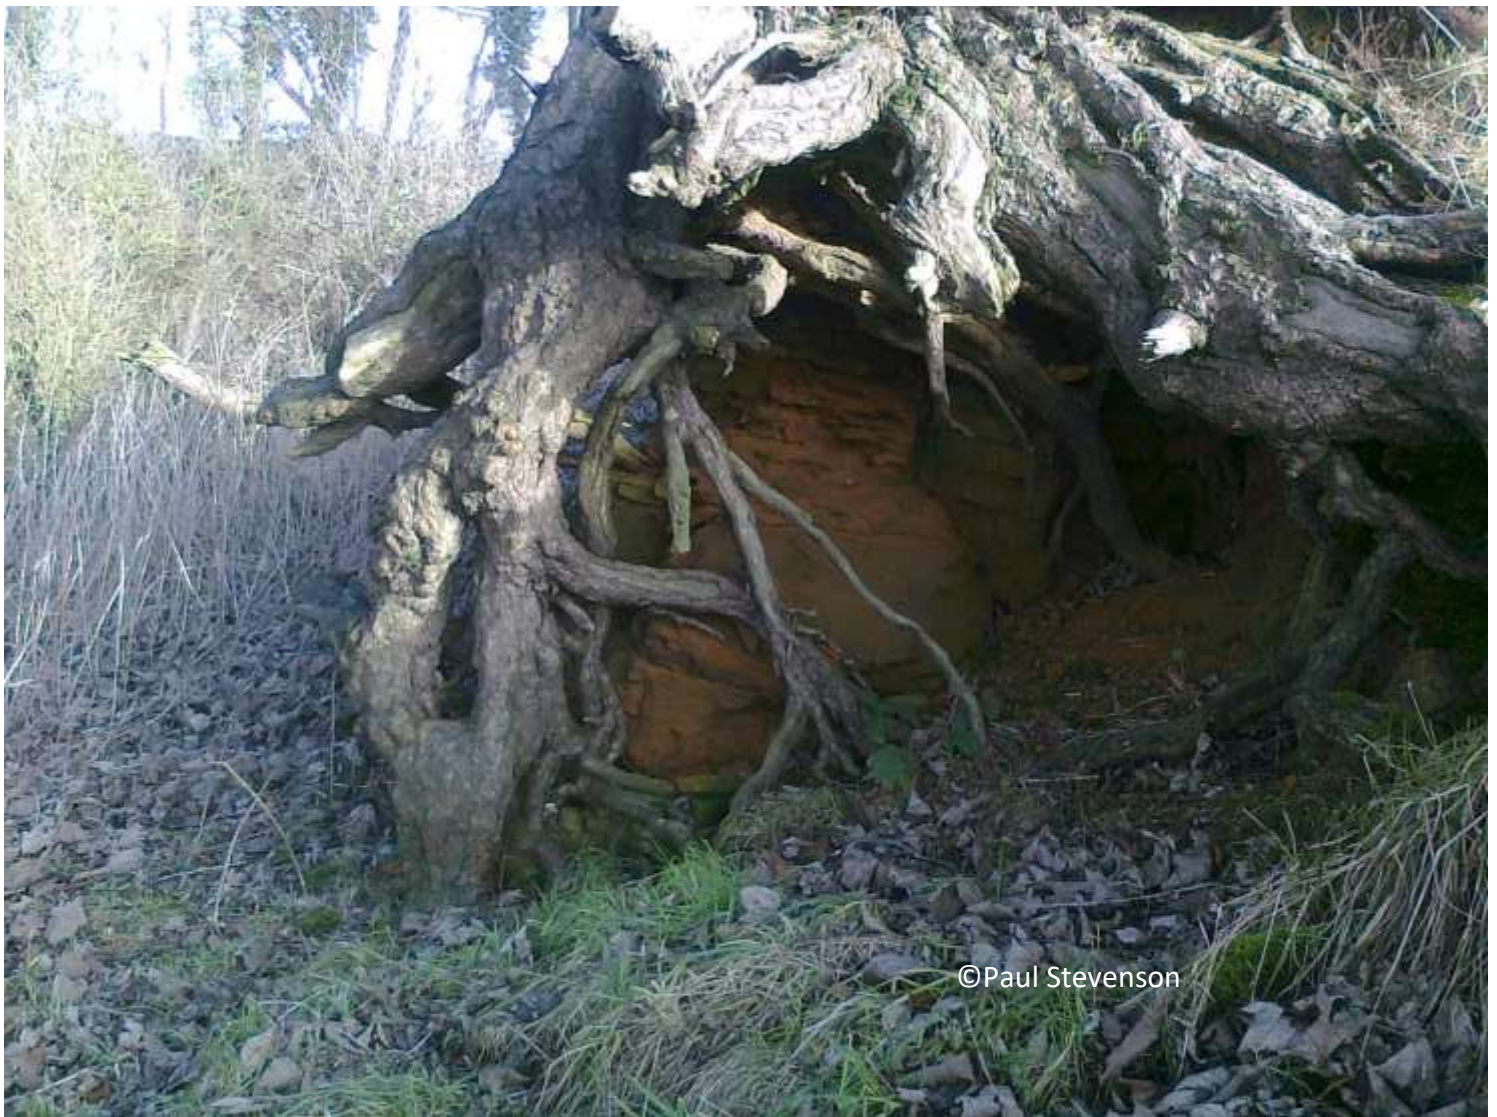
The photograph below is not the full extent of the exposure; the other part is just behind (to the East) of this piece. This piece shown in the photo is being protected (?) by a medium sized probably Scots Pine. When this falls over in the next 5-10 years it will cause damage but hopefully expose a new face. Pieces of iron ore can be found on the ground. The site could benefit from some strimming and digging out of the talus build up.
