Warwickshire Geological Conservation Group (WGCG)

Local Geological Site - LGS 92 Chapel Green, Update November 2020

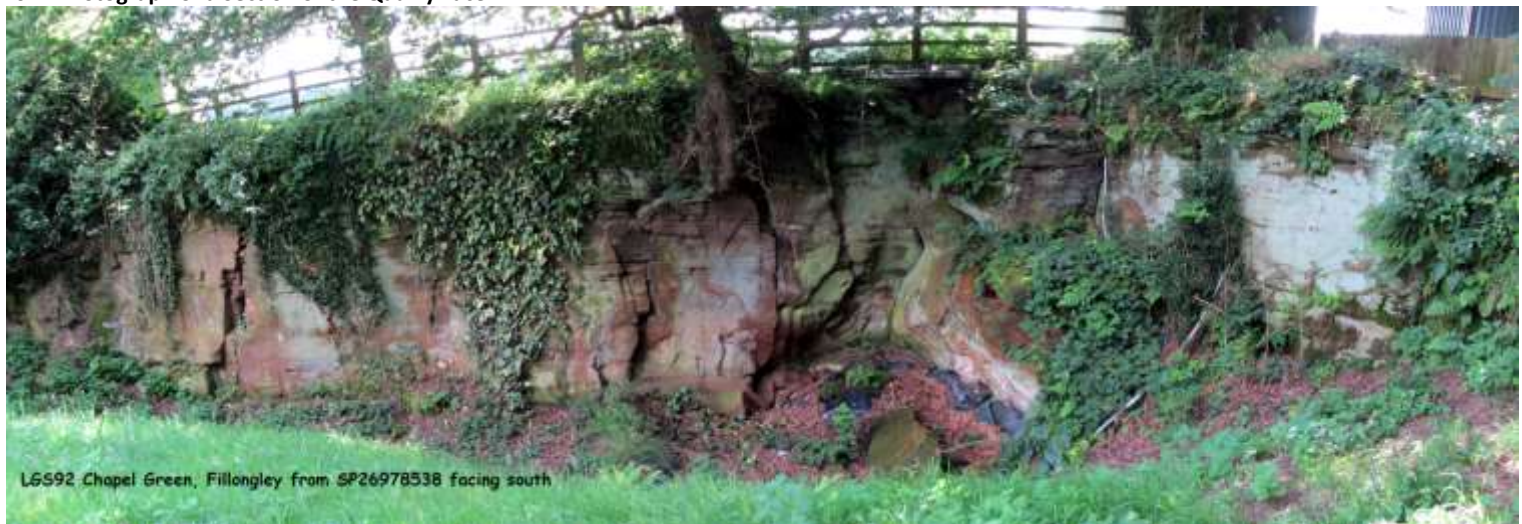
L6592 Chapel Green, Fillongley from SP26978538 facing south

Section 1 (South side): comprises a quarried face c.25m x 6m high in the Keresley Member of the Salop Formation (Upper Carboniferous) which has weathered to reveal cross-bedding. The sediment in the lower 1.5m has accumulated as a massive, well jointed, uniform medium to coarse ferruginous gritstone. Above, there is 2m of well jointed, thinly bedded sandstone.

2012 Photograph of a Section of the Quarry Face
